Service Bulletin

SUBJECT	: Steering vibration
APPLICABLE MODEL	: SN413(JS3JB43V834161319~ JSAFJB43V00170547~) SN415(SOP~)
EFFECTIVE ENGINE OR FRAME NO.	: 2009/3/2~ JSAFJB43V00422454~ (E02,E06,E11,E21,E22,E24,E37) JSAFJB53V00420452~ (E22) JS3JB43V3A4100053~ (E10) JS3JB43V694103542~ (E43) JS3JB43V294103554~ (E50) JS3JB43V694103556~ (E85)
REFERENCE	:

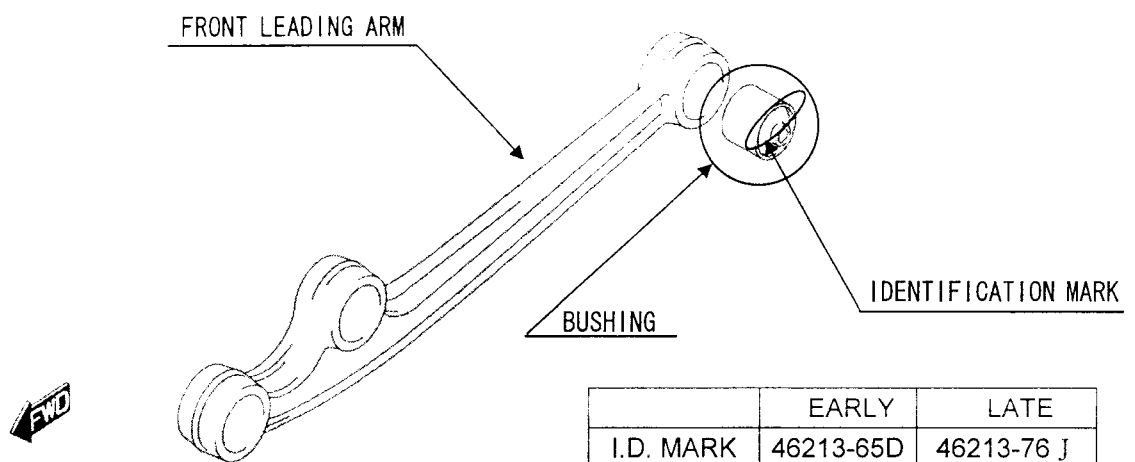
PART NAME	PART No.		INTERCHANGE ABILITY (O: YES, X: NO)	UNIT/PER
	EARLY	LATE		
BUSHING, BODY SIDE	46213-65D01	46213-76J00	EARLY → ← LATE	2

- Along with this change, rear trailing arm bushing has also been changed as unification, but the change has no relation to this countermeasure.

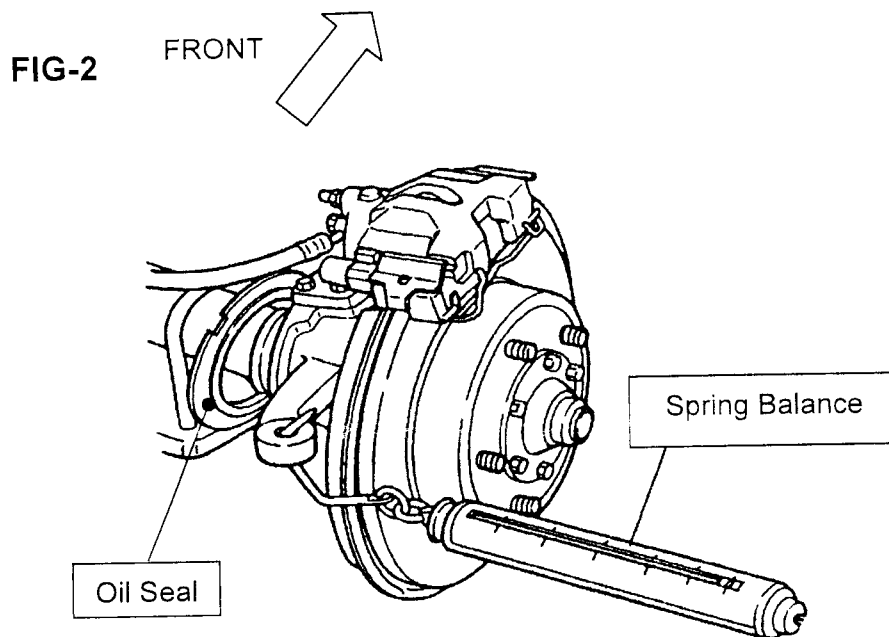
Please make sure start-up load should stay 4.6kg(45N) or less. If start-up load exceeds 4.6kg(45N), it might cause loss of steering returning performance or/and damage of kingpin bearing.

2. After adding shim, remove oil seal, tie-rod, and drag rod which are assembled on steering knuckle. And then, after shaking knuckle right and left around 20 to 30 times, measure start-up load by hooking a spring balance to tie-rod fixing hole of knuckle arm (which extends toward the rear of vehicle). Make sure start-up load is 4.6kg(45N) or less (Ref. : FIG-2).
